# **BM91535H FITTING ADVICE (PT. 2)**

BM91535HPT2\_V01

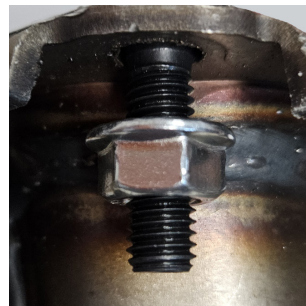
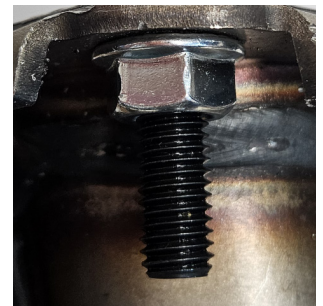
**Scenario 1**

Stud showing minimal blank section; the nut will sit flush/tight to the flange

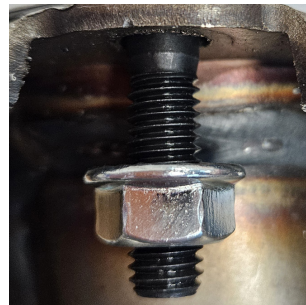
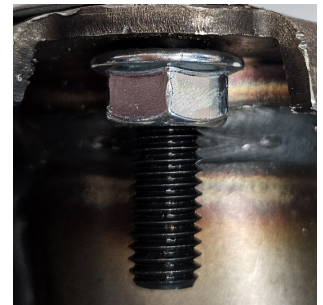
**Scenario 2**

The studs in the cylinder head should be fully tightened, up to the shank and not unwound. If the studs are unwound this will be indicated by visible threads between the shank and the cylinder head. This unwinding can happen during removal of the previous/original catalytic converter. If this has occurred and it is not possible to re-tighten the studs, then it may be necessary to use a washer between the flange and the nut to ensure there are sufficient threads available to tighten that specific nut. The use of washers does have an additional advantage of spreading the load of the nut over a larger surface area of the flange.

Stud showing large blank section; the nut will not sit flush/tight to the flange

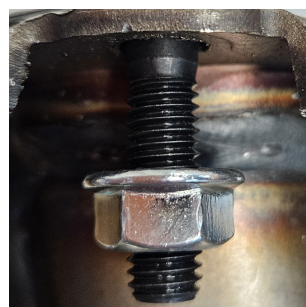
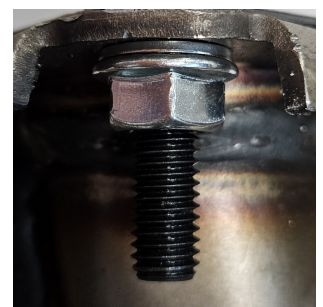
**Scenario 3**

Stud showing large blank section; the addition of a washer will enable the nut to sit flush/tight to the flange
